APPLICATION OF ADVANCED COATING TECHNIQUES TO ROCKET ENGINE COMPONENTS

S. K. Verma^{*}

ABSTRACT

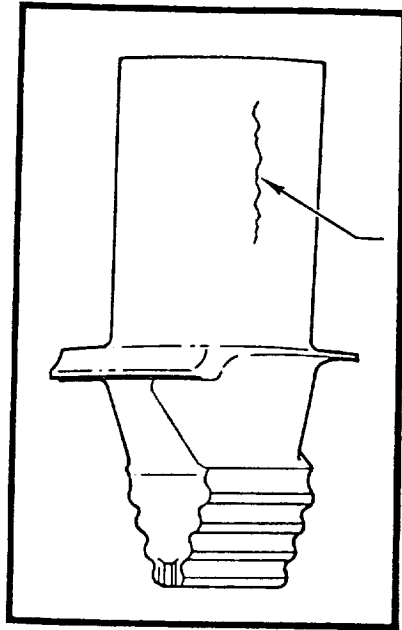
A schematic representation of radial airfoil cracks is shown in Figure 8. The intergranular cracks were caused by thermal fatigue and were eliminated by application of blade coatings. The platform cracks were both intergranular and interdendritic and were also caused by thermal fatigue. A typical schematic representation of such cracks is shown in Figure 9. Additionally, there were signs of overburnt areas in the

- INTERGRANULAR CRACKS
- CAUSED BY THERMAL FATIGUE
- ELIMINATED BY APPLICATION OF BLADE COATING

Figure 8. Schematic representation of radial airfoil cracks in first-stage blades. (Source: Rocketdyne.³)

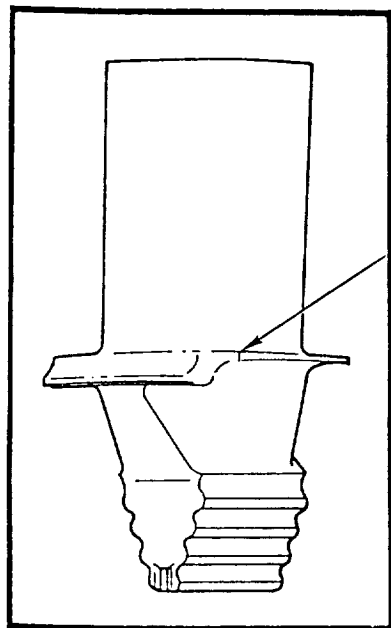
- INTERGRANULAR (IG) AND INTERDENDRITIC (ID) CRACKS
 - THERMAL FATIGUE
- ONLY RISK IS ASSOCIATED WITH LINKING OF CRACKS OR TRANSITION TO TRANSVERSE CRACK
- BOROSCOPE INSPECTION

Figure 9. Schematic representation of platform cracks in first-stage blades. (Source: Rocketdyne.³)

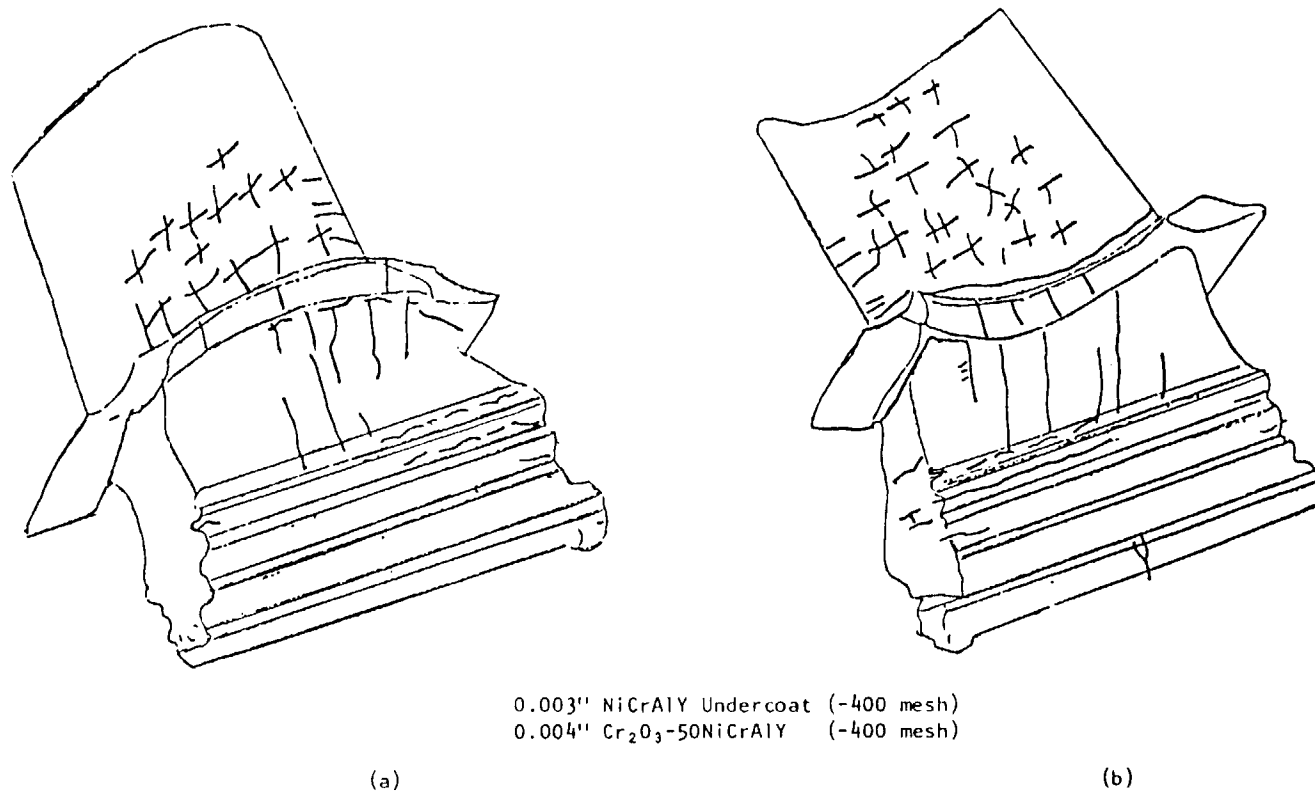
In these tests, the thermal cycle was characteristically a nominal maximum chamber temperature of approximately 1700°F (927°C) and a nominal maximum chamber pressure of approximately 2500 psi, down to a nominal minimum chamber temperature of -350°F (-212°C) and a nominal minimum chamber pressure of 160 psi. Figure 12 is a plot of a high, a nominal, and a low chamber temperature seen during the course of the testing. For simplicity, two of the schematics prepared by NASA-Marshall are shown in Figure 13 illustrating the type of cracking. In fact, all the coatings of various compositions applied by conventional methods had cracks of the type shown in Figure 13.⁵

Figure 13. Schematic representation of cracks formed on (a) concave and (b) convex sides of turbine blades tested in NASA-Marshall's thermal fatigue rig simulating the operation of space shuttle main engine.⁵
